DN9331

Software

Updates

Instruction Notes

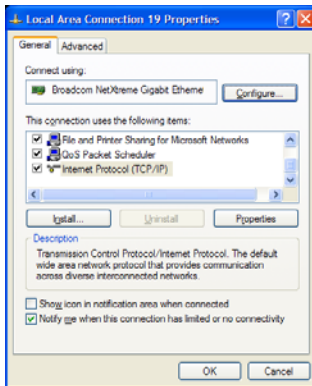
Scroll down the list until you can see Internet Protocol (TCP/IP), highlight this and click on properties.

Enable the Use the following IP address and then fill in the IP address and Netmask

IP – 192.168.20.3

Netmask 255.255.0.0
